HEYBURN STATE PARK/ BENEWAH CAMPGROUND ROAD IMPROVEMENTS

IDAHO DEPARTMENT OF PARKS AND RECREATION

APRIL 2009

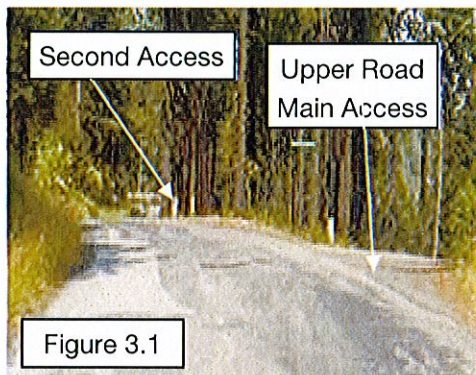
Figure 3.1

The intersection has two access points from Chatcolet Road to Upper Chatcolet Road. The main access point was constructed when the road was constructed and is shown in Figure 3.1. Neither access intersects Chatcolet Road at right angles which limits the site distance of a vehicle on Chatcolet Upper Road. Also the grade of the approaches is very steep which makes it difficult for a vehicle to start moving and enter the traffic on Chatcolet Road. Some of the vehicles at this intersection are towing a boat or trailer which limits the speed of the vehicle entering the intersection.

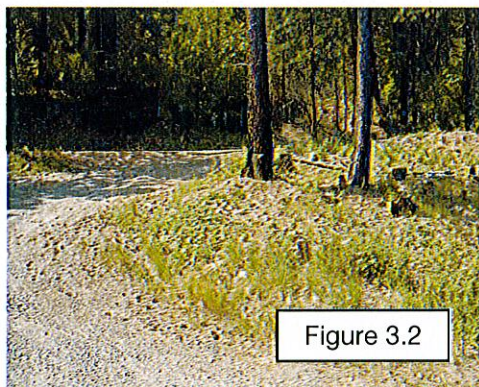
Figure 3.2

The existing alignment also causes clearance problems for vehicles turning from one road onto the other. Drivers created a second access to accommodate the clearance problems and the second access is shown in Figure 3.1 and 3.2. The grade of the second access is very steep with limited site distance at the intersection.

1. The intersection should be redesigned so the centerlines intersect at right angles. The realignment will have the following advantages:

- Increase the site distance for vehicles entering the intersection.

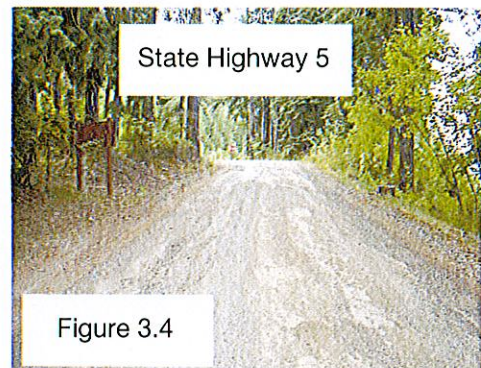
Figure 3.4 is Rocky Point Road with State Highway 5 in the distance. Figure 3.5 is the same intersection but from the perspective of State Highway 5. The site distance for vehicles leaving Rocky Point Road is limited due to the configuration

of the intersection.

1. Realign Rocky Point Road so that it intersects State Highway 5 at right angles. The realignment will have the following advantages:

- Increase the site distance for vehicles

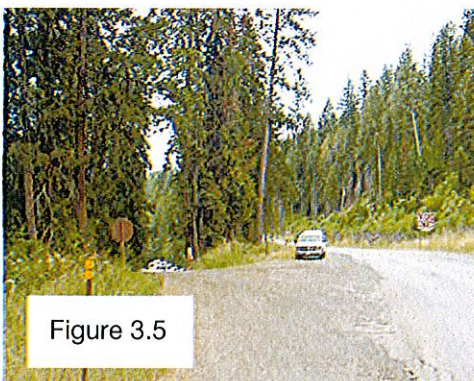
Vehicles that are towing a boat have a tight turn radius in order to turn from State Highway 5 onto Rocky Point Road as can be seen in Figure 3.5.

- Provides increased turning area for vehicles towing a trailer or boat to maneuver from State Highway 5 to Rocky Point Road.

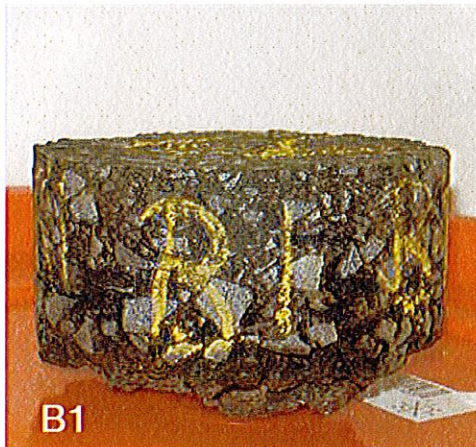
The asphalt core from coring B1 is shown on the left. The thickness of the asphalt was approximately 1¾ inches and the asphalt was underlain by 1½ inches of base rock. The subgrade soil consisted of poorly-graded gravel and the largest nominal size of gravel was approximately 2 inches.

We recommend this roadway be reconstructed due to the topsoil and the inadequate base course. The topsoil beneath the pavement should be removed. The roadway should then be regraded to facilitate drainage. The traffic on the access

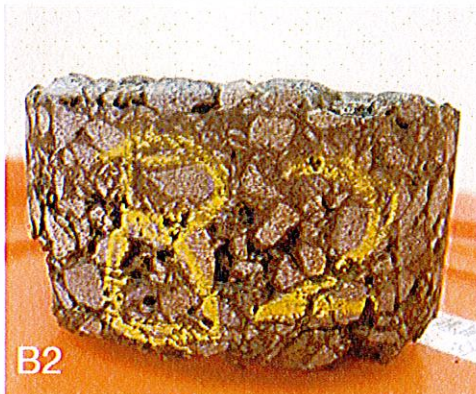
The core B2 consisted of approximately ¾ inches of hot mix asphalt which was underlain by approximately 1 inch of a chip seal material. The hot mix layer and chip seal layer are apparent in the picture of the core. Base course was encountered under the asphalt and was approximately 5 ½ inches thick. Topsoil with organics was encountered to approximately 14 inches below the pavement surface. The depth of the topsoil may be deeper but we were unable to advance the hand auger any further due to the size of the cobbles that were encountered.

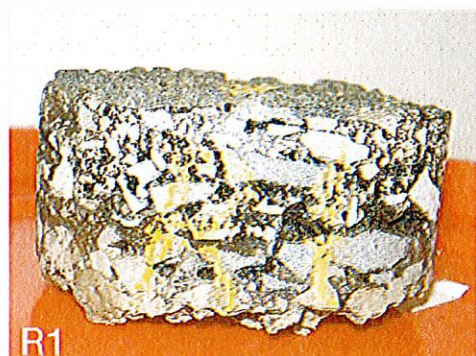
This core sample was obtained on the boat launch access road. It appears that two chip seal layers were applied to the roadway. The upper layer contained more fine-grained aggregate. The asphalt core is approximately 2 inches thick. So both chip seals were approximately 1 inch in thickness. The asphalt was underlain by 6 inches of base rock and the subgrade soil consisted of silt soil.

- Due to the amount of vehicles accessing the boat launch, the boat launch road should be asphalted. The road will need to be graded. Base rock and asphalt will need to be placed. We recommend 3 inches of asphalt over 6 inches of base rock.

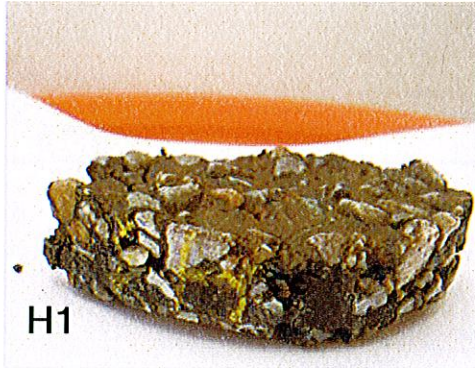
The core was taken from the access road. It appears the asphalt surfacing is a chip seal and is approximately 0.75 inches thick. A 3½ inch layer of base course underlies the chip seal. The subgrade is silt soil.

We recommend the entrance and the RV Dump Station be surfaced with hot mix asphalt. Additional base course will also be required. We recommend the roadway and the RV dump site be reconstructed and paved with 3 inches of asphalt underlain by 12 inches of base rock.

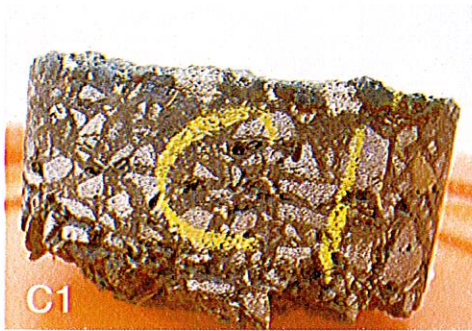
The first core was located just south of the bike trail on Chatcolet Road. The asphalt thickness was approximately 1 1/4 inch and was underlain by 8 inches of base rock.

- Chatcolet Road from the new visitor center to approximately 500 feet north of the existing park headquarters has approximately 1 to 1.25 inches of asphalt. The roadway should be reconstructed to 3 inches of asphalt underlain by 12 inches of base rock.
- From 500 feet north of the existing park headquarters to the lower Chatcolet road the asphalt thickness increases to 3 to 5 inches. The thickness of the existing asphalt is adequate. At this time we do not recommend any reconstruction on this portion of the roadway. However, the roadway should be sealed to prevent water from affecting the subgrade.

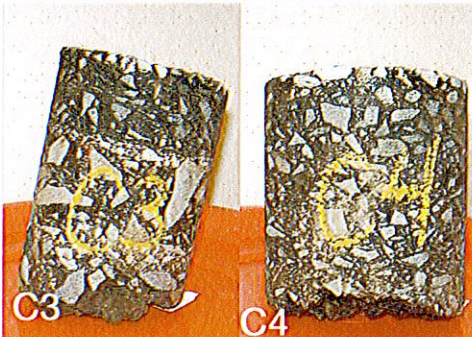
The next core, C3, was located on the lower Chatcolet road. The asphalt thickness was a total of 5 inches and consisted of a 1 1/2-inch overlay of 3/4-inch-class hot mix asphalt underlain by 3-inches of 1 1/2-inch-class hot mix asphalt which was underlain by a chip seal. Approximately, 1 inch of the chip seal is visible in the left side of the core picture and the rest of the chip seal came out in pieces. The total chip seal was approximately 2 inches thick. The asphalt was underlain by 5 inches of base rock.

- The lower road has thick asphalt from Chatcolet road to the boat launch. Past the boat launch the asphalt had deteriorated. We recommend the northern end be reconstructed with 3 inches of asphalt over 12 inches of base.

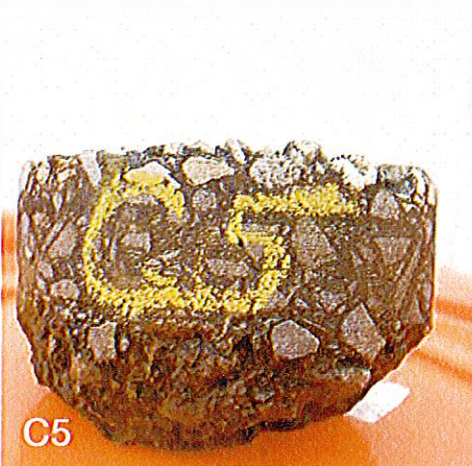
The next core, C4, was located on Chatcolet road. The core thickness is about 3 1/2 inches of hot mix asphalt and was underlain by 8 inches of oil-treated base rock. The oil-treated rock consisted of highly-fractured coarse gravel. Cobbles were encountered beneath the base course and so the hand auger could not be advanced.

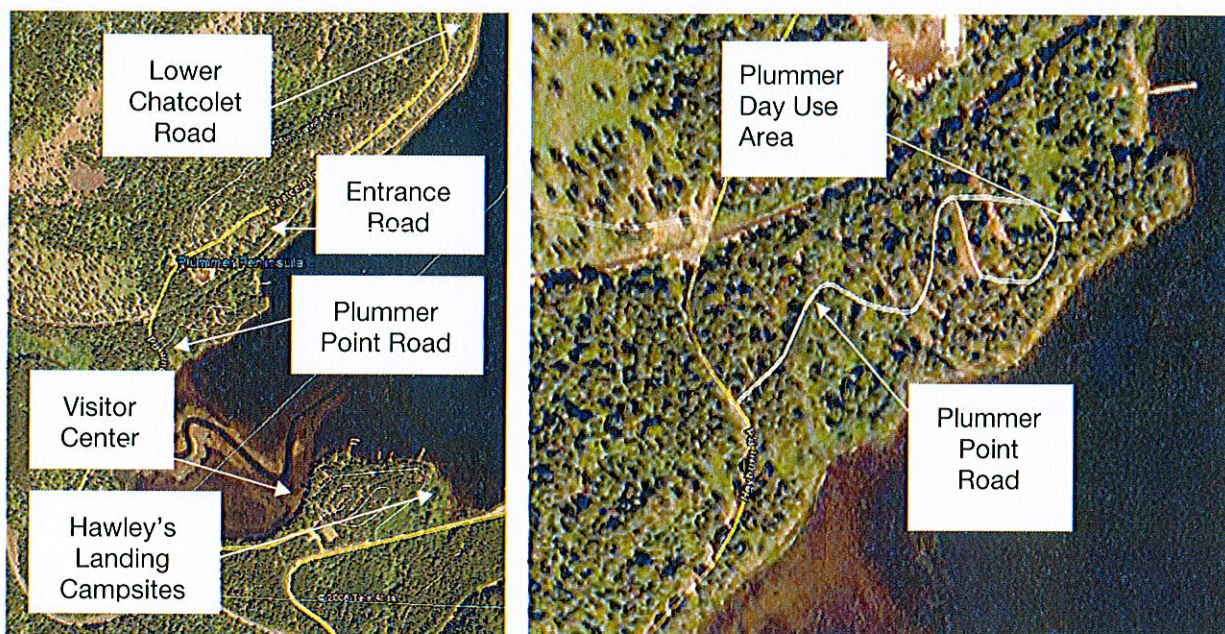
Figure 3.21: Plummer Point Day Use Access Road Overview

Roadway Name	Length of Roadway (feet)	Width of Roadway (feet)	Existing Pavement Surface	PASER Rating	Surface Pavement Conditions
Plummer Point	1,930	20	Gravel	4	Road is in relatively good condition. Slope for drainage is adequate.

A test pit was completed on the roadway. It appears there is approximately 4.5 inches of gravel on the roadway which is underlain by poorly graded gravel. The road should be shaped and stabilized for dust control.
